Docket No. 217 – Development and Management Plan Inspection

Northeast Utilities Service Company Certificate of Environmental Compatibility and Public Need for the construction of a 345-kV electric transmission line and reconstruction of an existing 115-kV electric transmission line between Connecticut Light and Power Company's Plumtree Substation in Bethel, through the towns of Redding, Weston, and Wilton, and to the Norwalk Substation in Norwalk, Connecticut.

Date: October 4, 2006

Location: Overhead Line (Composite 345kV and 115kV Gallows Hill to Archers Lane, 345kV H-Frame Hoyts Hill to Gallows Hill, and Norwalk Section)

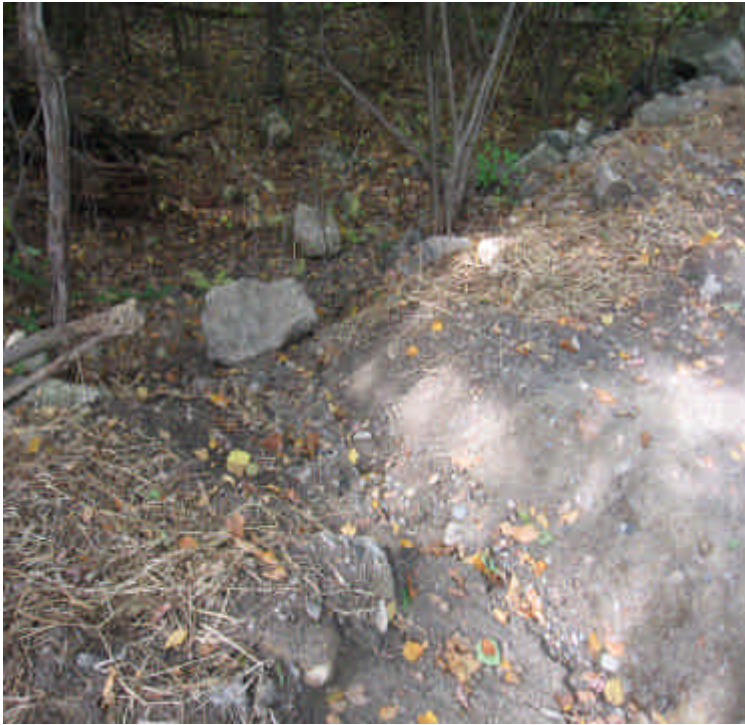
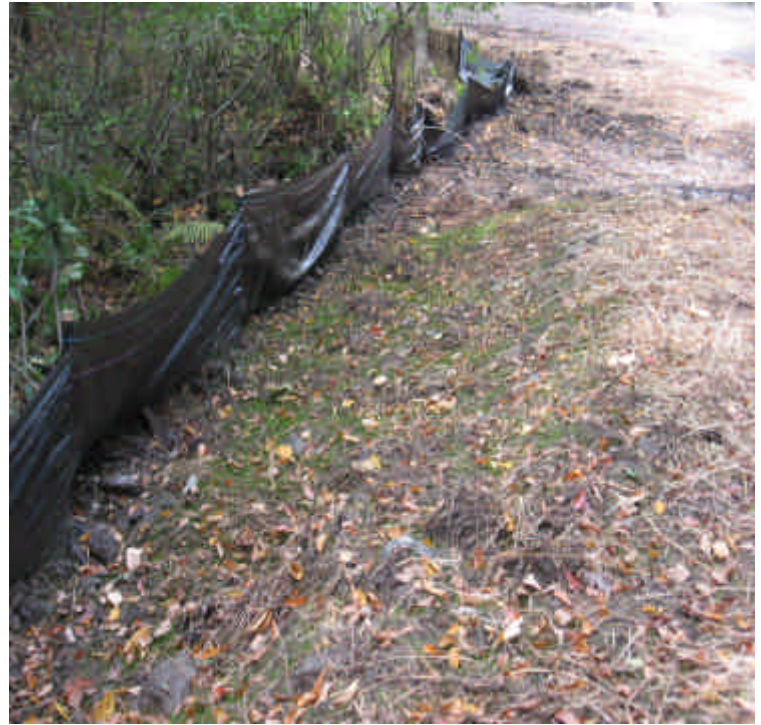
(Composite Section): Photo on the left shows that haybales have not yet been placed at the water bar outlets within the access road at Archers Lane. Photo on the right shows grass growth at the first wetland crossing. Silt fence remains along the access road. 10/04/06.

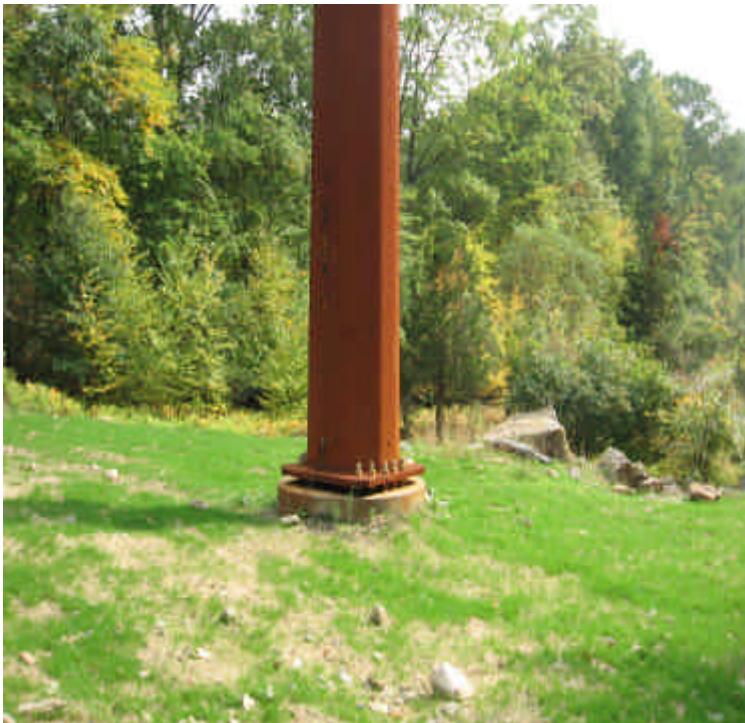
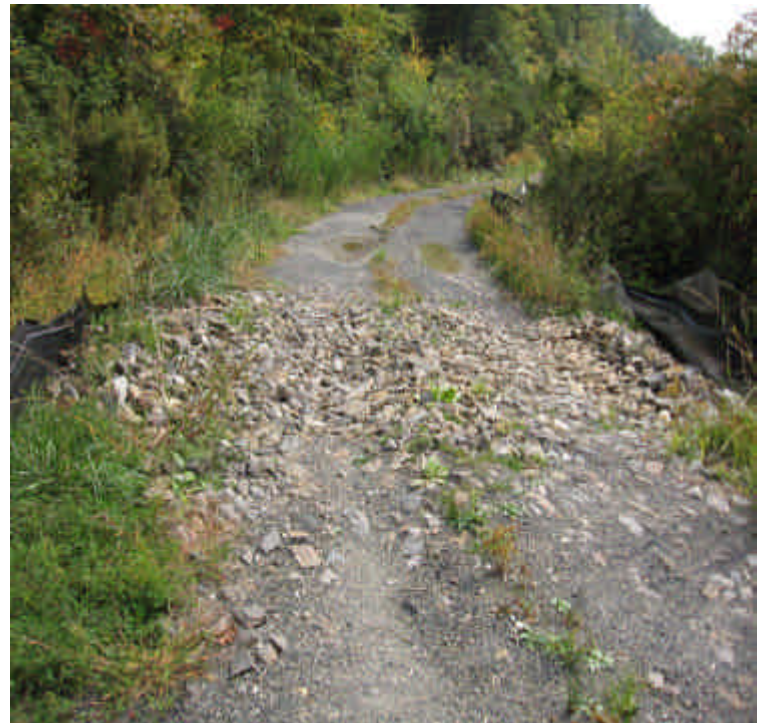
Photo on the left shows significant grass growth in the restored area at structure #34 off Gallows Hill Road. Photo on the right shows a view of the remaining stone wetland crossing here that needs to be removed. 10/04/06.

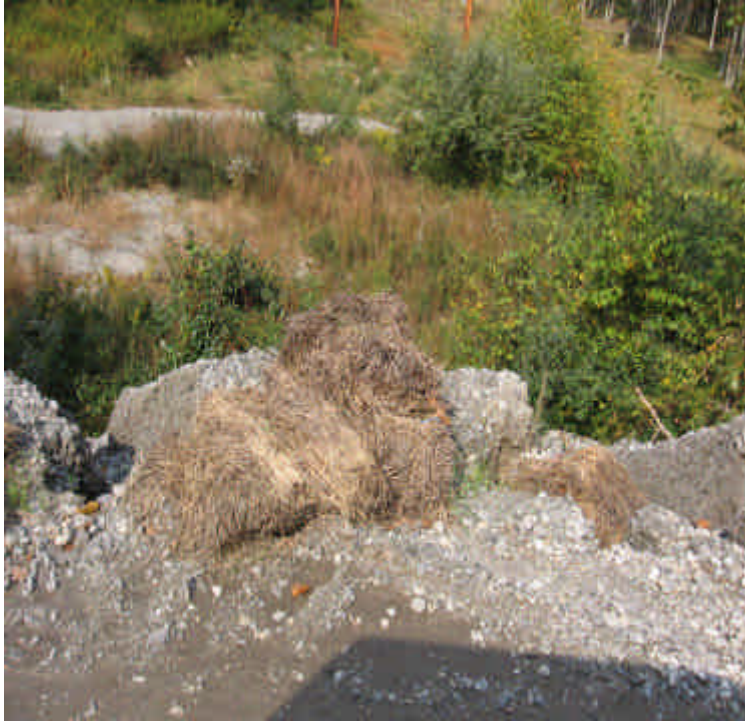
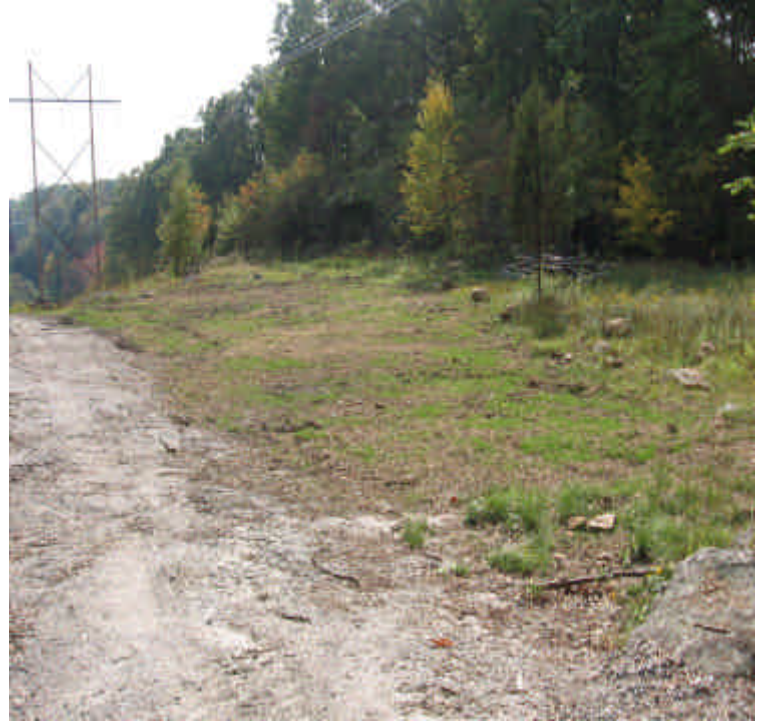
(345kV H-Frame): Photo on the left shows a view of the continued erosion in the access road near structure #31 off Costa Lane. Photo on the right shows increased grass growth in the restored areas along the ROW. 10/04/06.

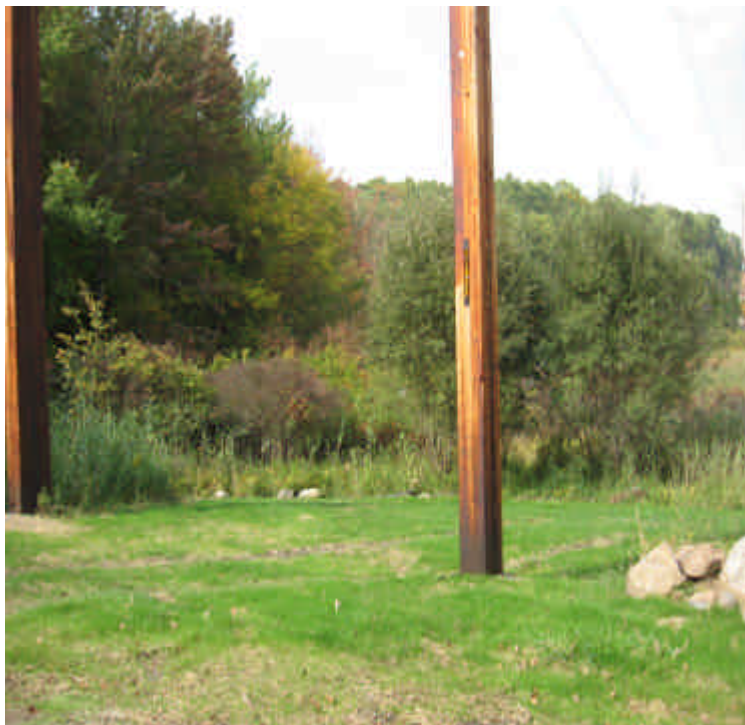
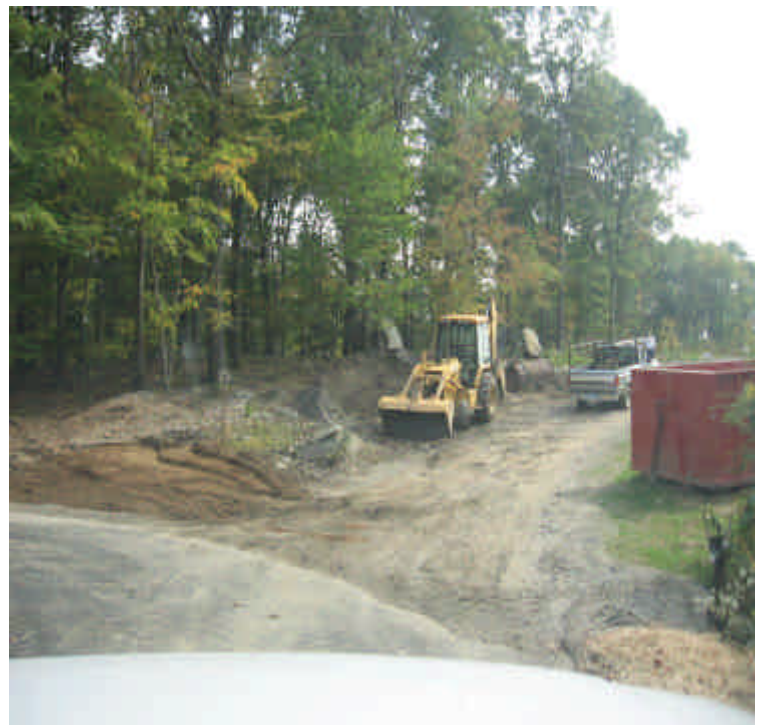
Photo on the left shows the restored area at structure #25 off Lime Kiln Road. Silt fence should be removed here. Photo on the right shows the private contractor continuing to work within the restored section of ROW off John Todd Way. 10/04/06.

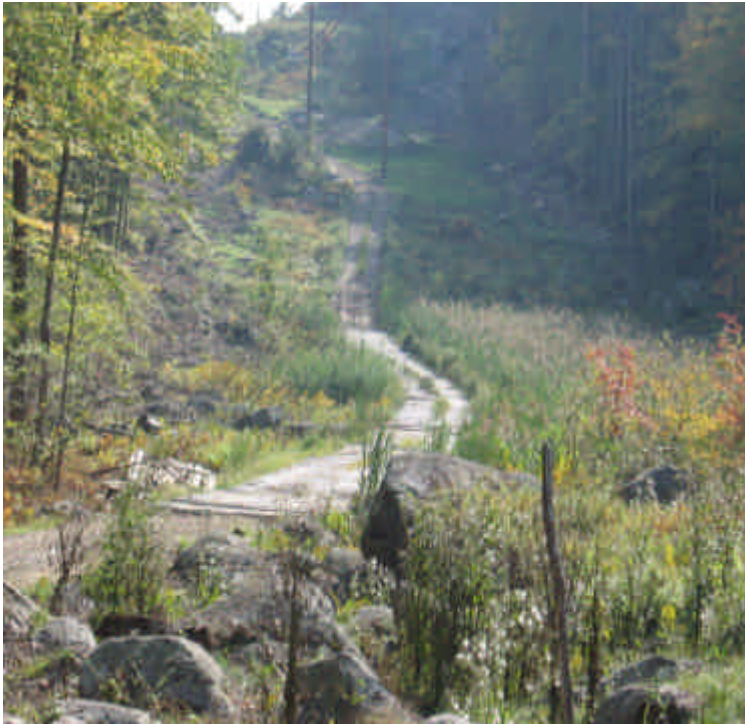
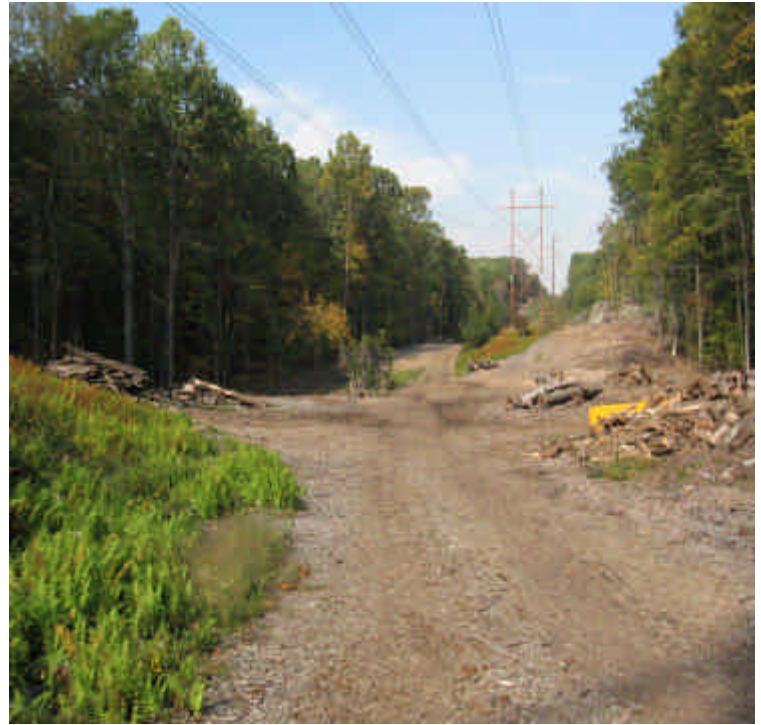
Photo on the left shows mats remaining at the first wetland crossing within the Bethel Reservoir section of ROW. Photo on the right shows piles of logs and brush remaining within the ROW here. 10/04/06.

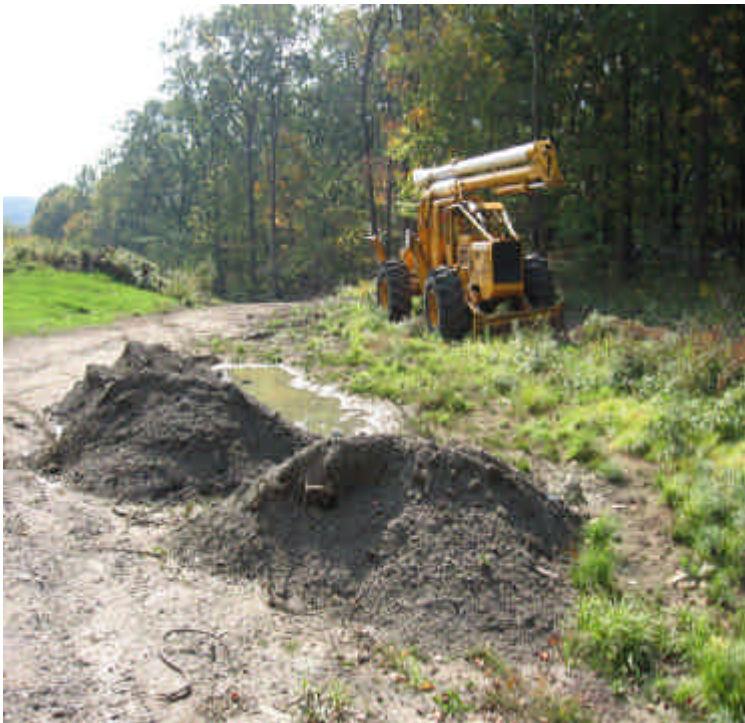
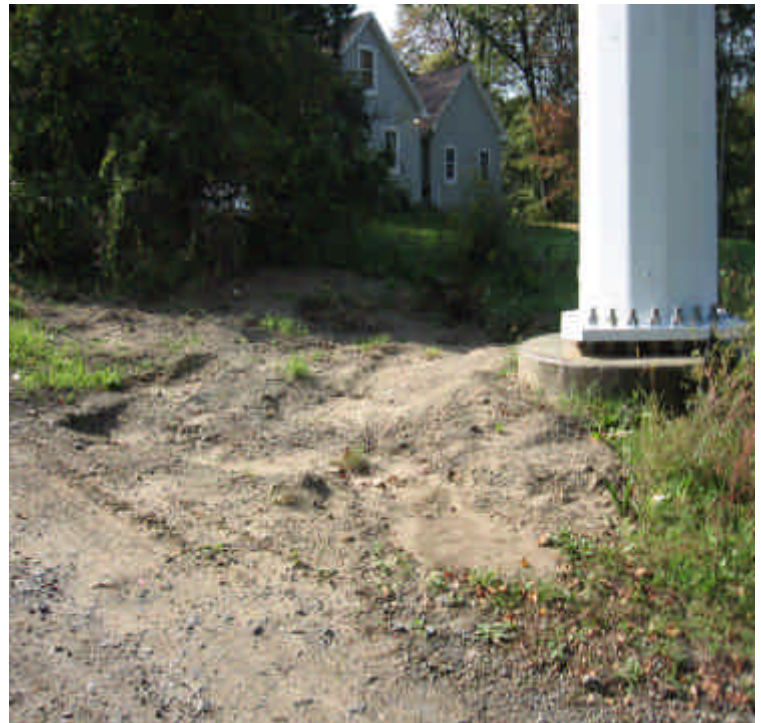
Photo on the left shows small stockpiles at structure #10. Equipment is also being stored here. Photo on the right shows the small disturbed area remaining at structure #9. 10/04/06.

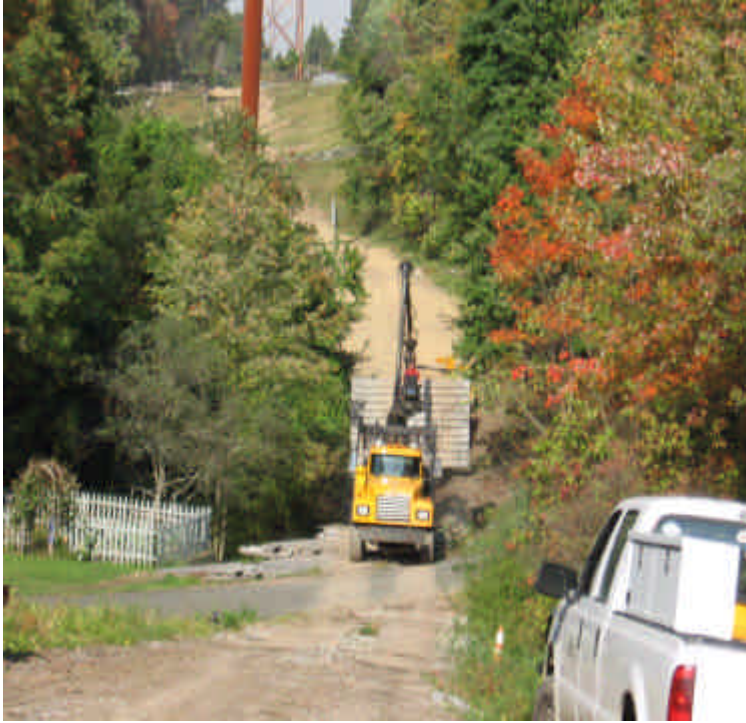
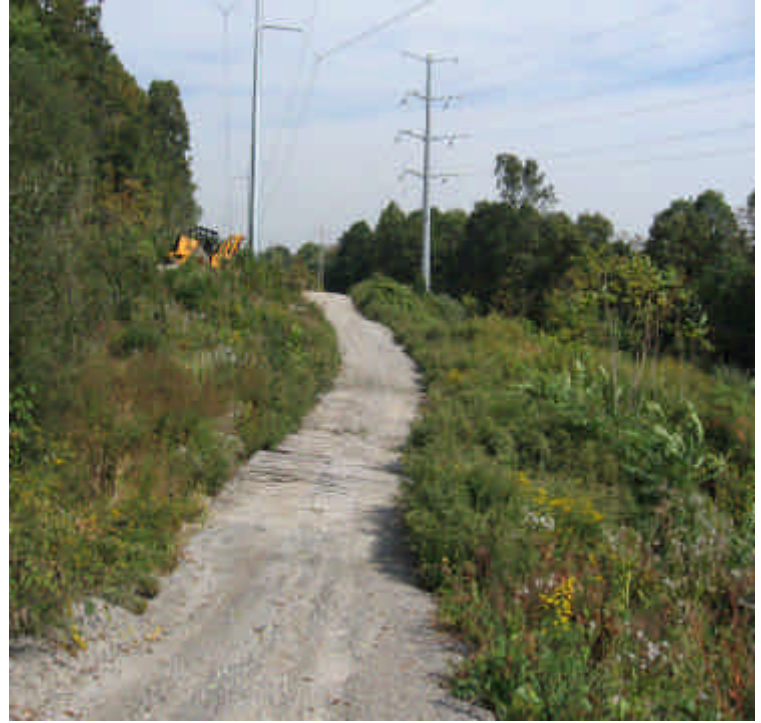
Photo on the left shows crews removing mats from the ROW access off Chestnut Ridge Road and restoring the access as they go. (Norwalk Section): Photo on the right shows mats remaining along the ROW off Kent Road (south). 10/04/06.

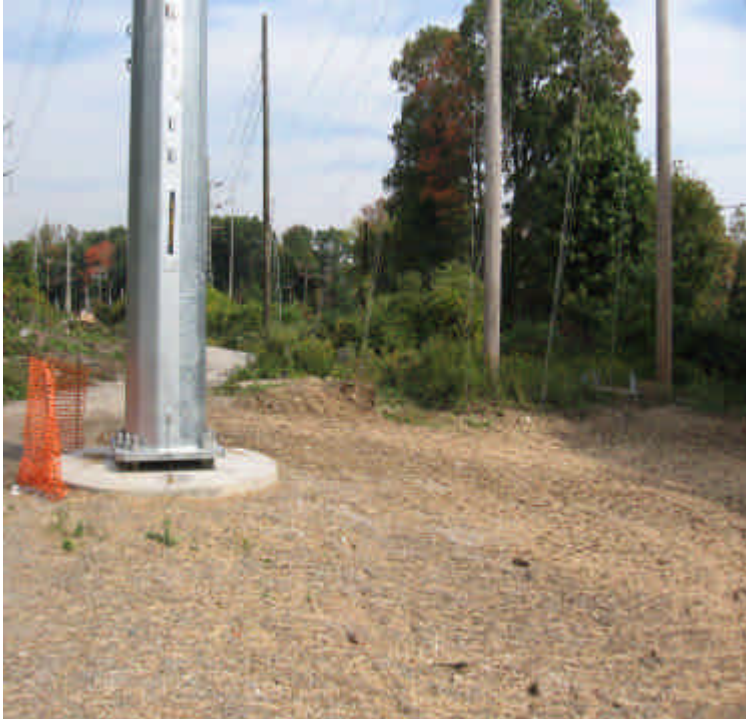
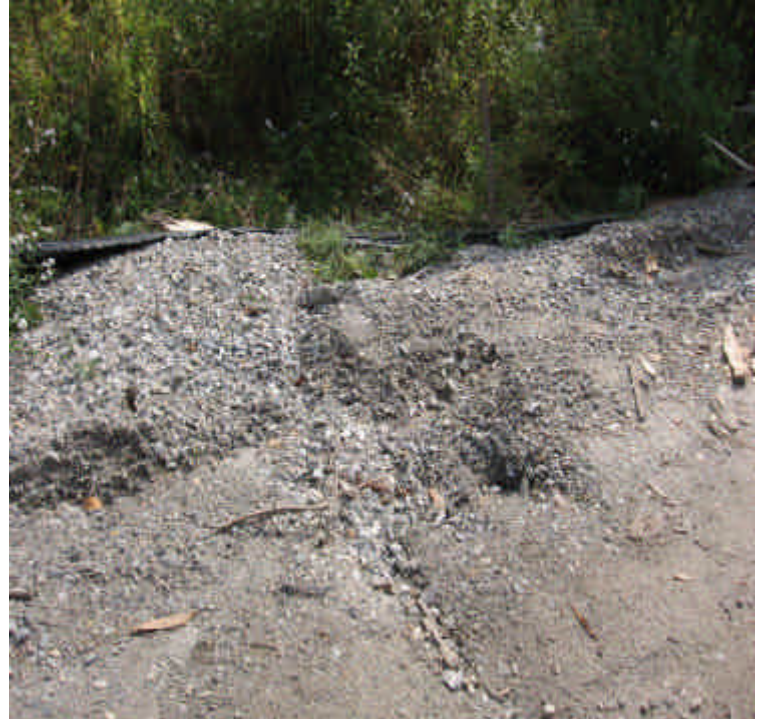
Photo on the left shows a view of a restored area within the ROW off Kent Road (south). Minimal grass growth was noted this week. Photo on the right shows wash outs continuing within the stone access road here. Haybales are deteriorating and some stone remains in the wetland. 10/04/06.

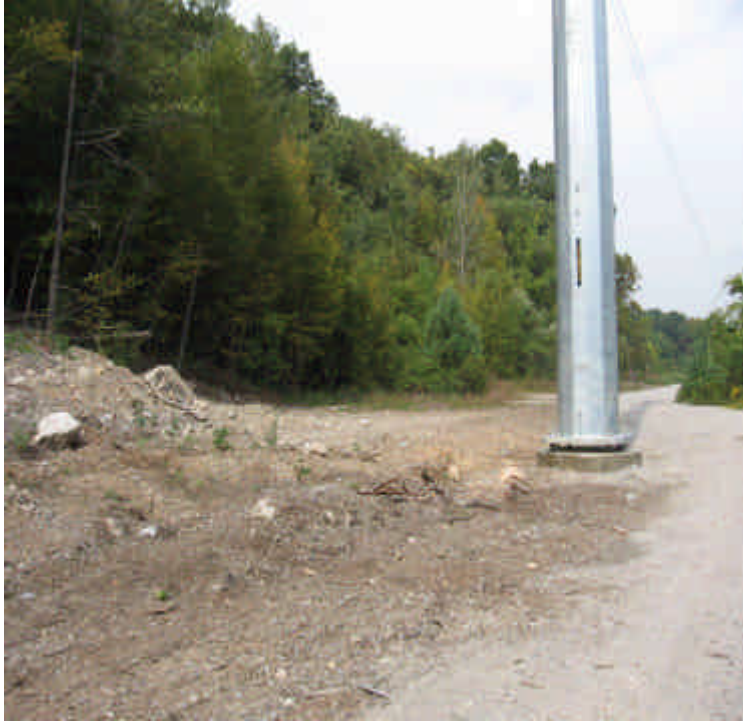
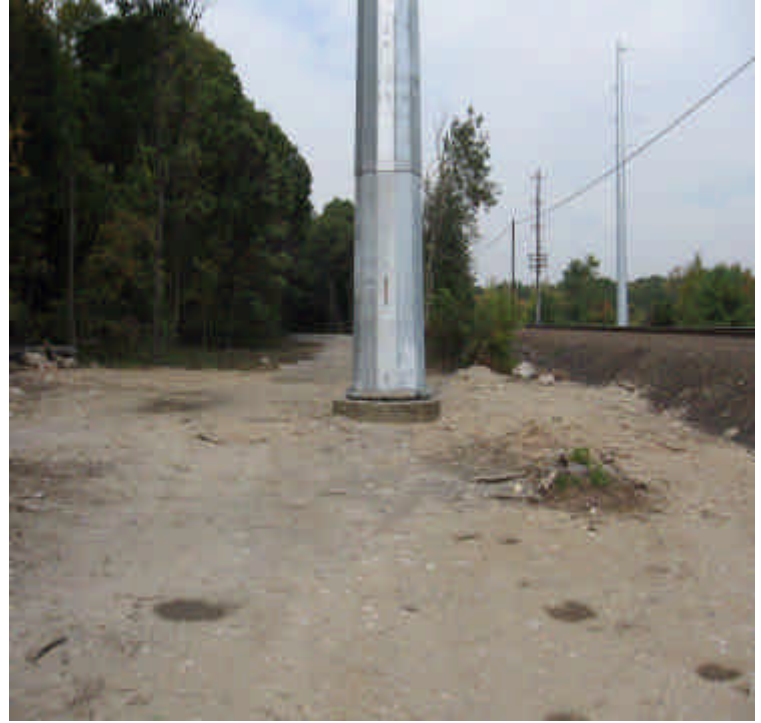
Both photos show areas that have not been restored in the ROW off Kent Road (north). All disturbed areas should be re-graded to original conditions and seed and hay mulch applied. 10/04/06

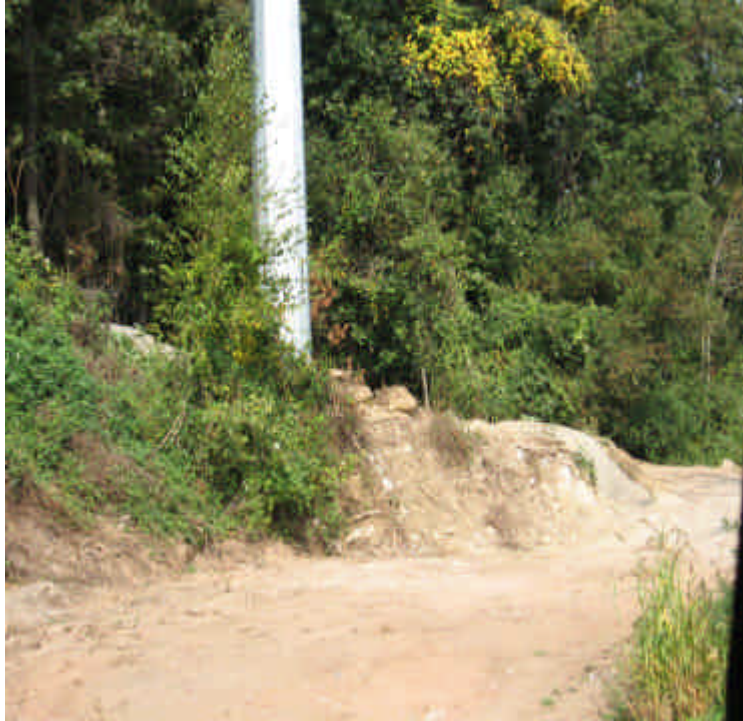
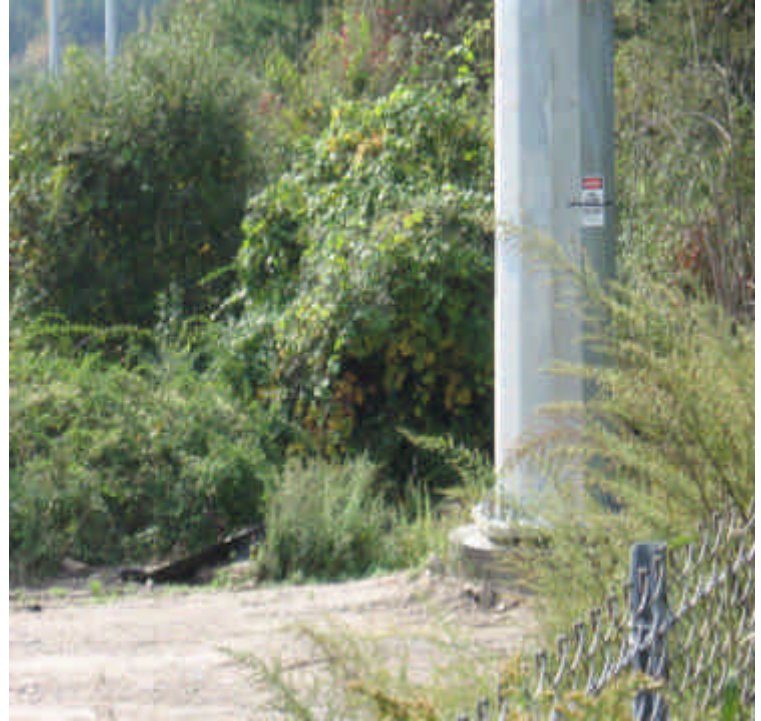
Both photos show disturbed areas that do not appear to have been restored within the ROW off North Seir Hill Road. Most areas were gated and locked at the time of inspection. 10/04/06.

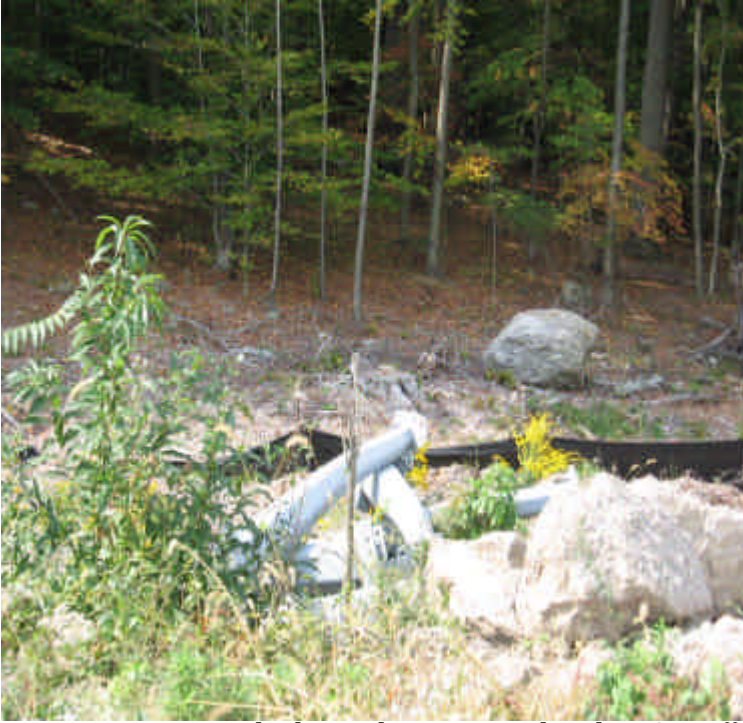
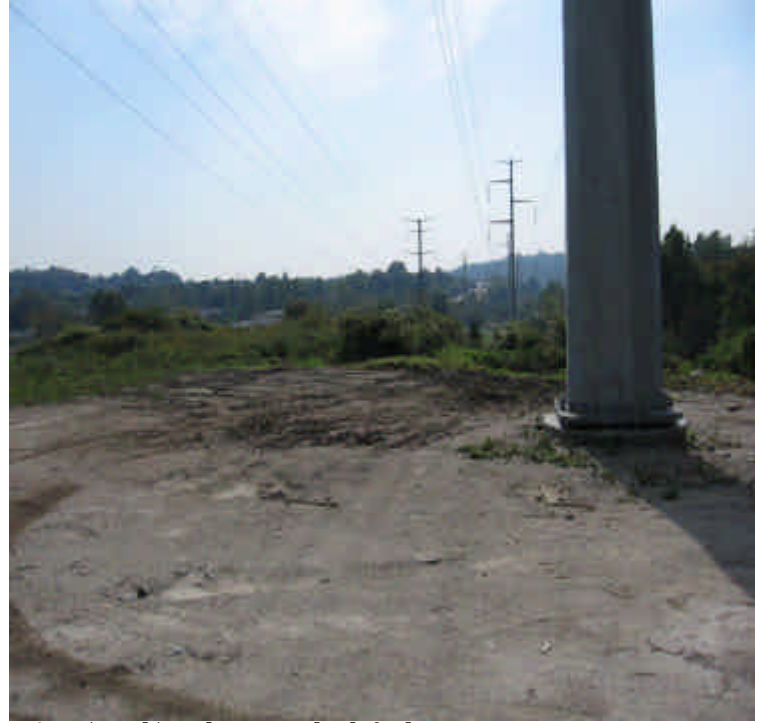
Both photos show areas within the ROW off Perry Ave (north). Photo on the left shows spare structure arms being stored near structure #11074 off Perry Ave. All old materials should be removed. Photo on the right shows one of the areas that has not been restored in this section. 10/04/06.

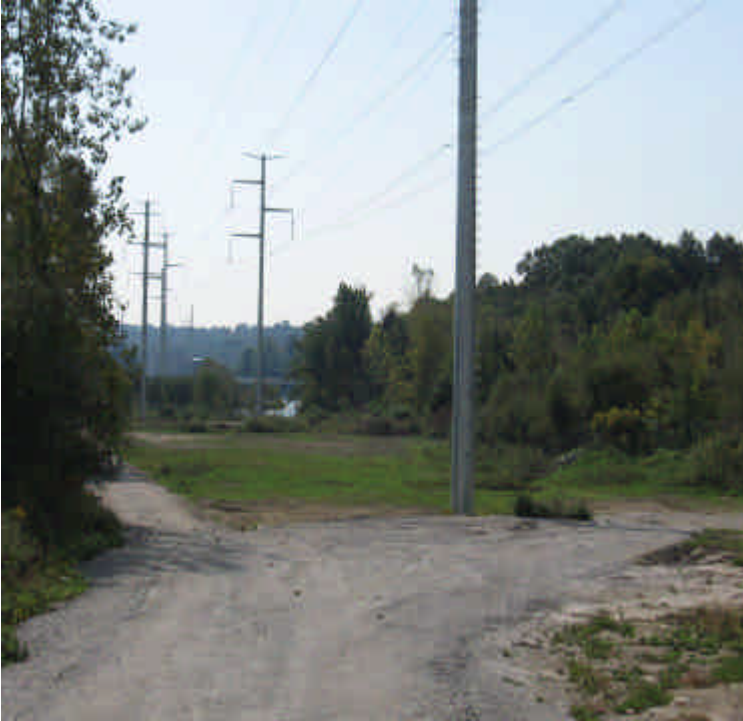
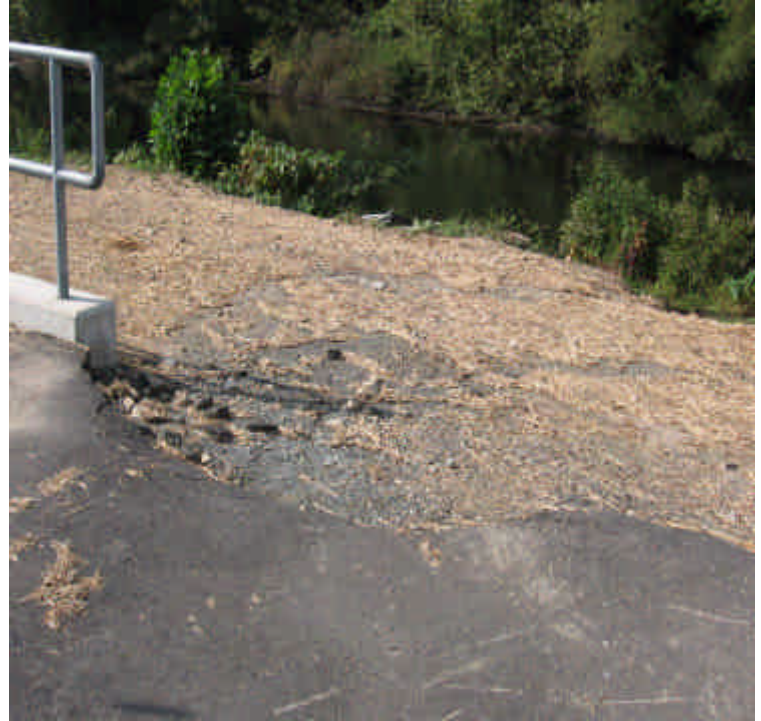
Photo on the left shows significant grass growth in the restored areas off Perry Ave (south). Photo on the right shows a view of the restored area near structure #11080. Storm water runoff from the paved bike path is washing out the seed and hay mulch into and pushing the silt fence down. Grass growth was not noted at the time of inspection. 10/04/06
